Evaluate Two High Performance Engines
Wessinger
Ms. Lucy Webster
Location Not Applicable To File

June 13, 2011

REFERENCE: Evaluate Two High Performance Engines
Client: Wessinger
McGowan Hood & Felder File Number: 02-11-0062
ED&T File Number: COL15183-57153

The following is a report concerning an investigation of two high performance engines that were assembled by Tyler Crockett Marine Engines. The purpose of this investigation has been to evaluate the mechanical condition of the two engines to determine whether the quoted work was completed.

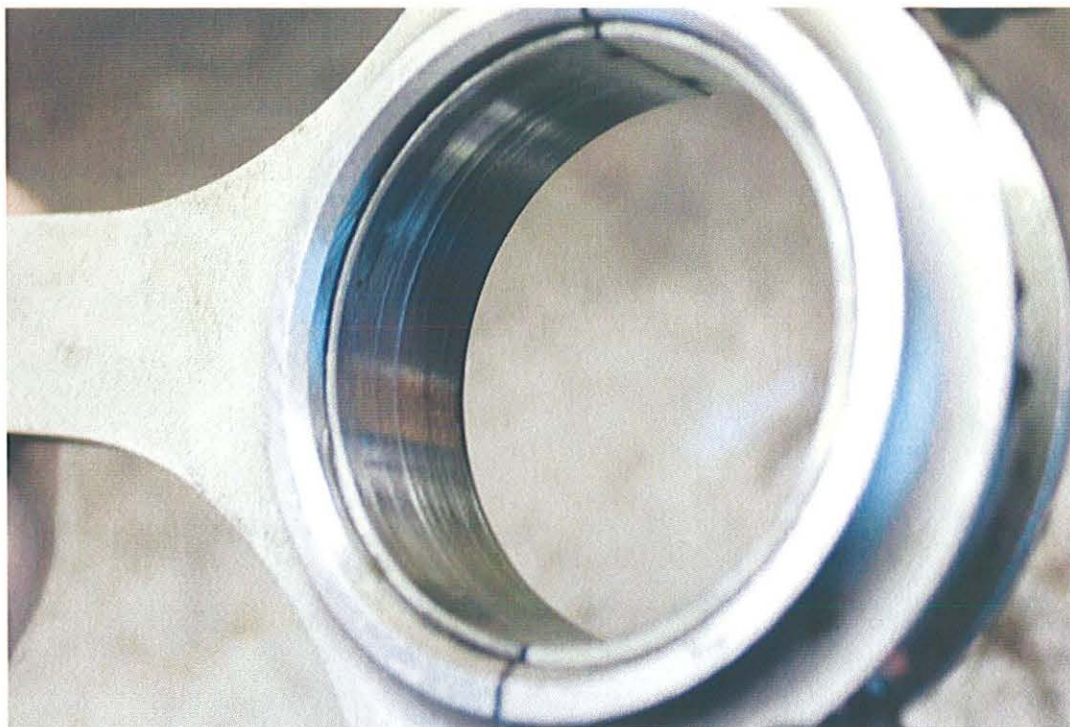
Figure B7 #378R: Indication of metal to metal contact on cylinder #2 connecting rod bearing (image cropped)

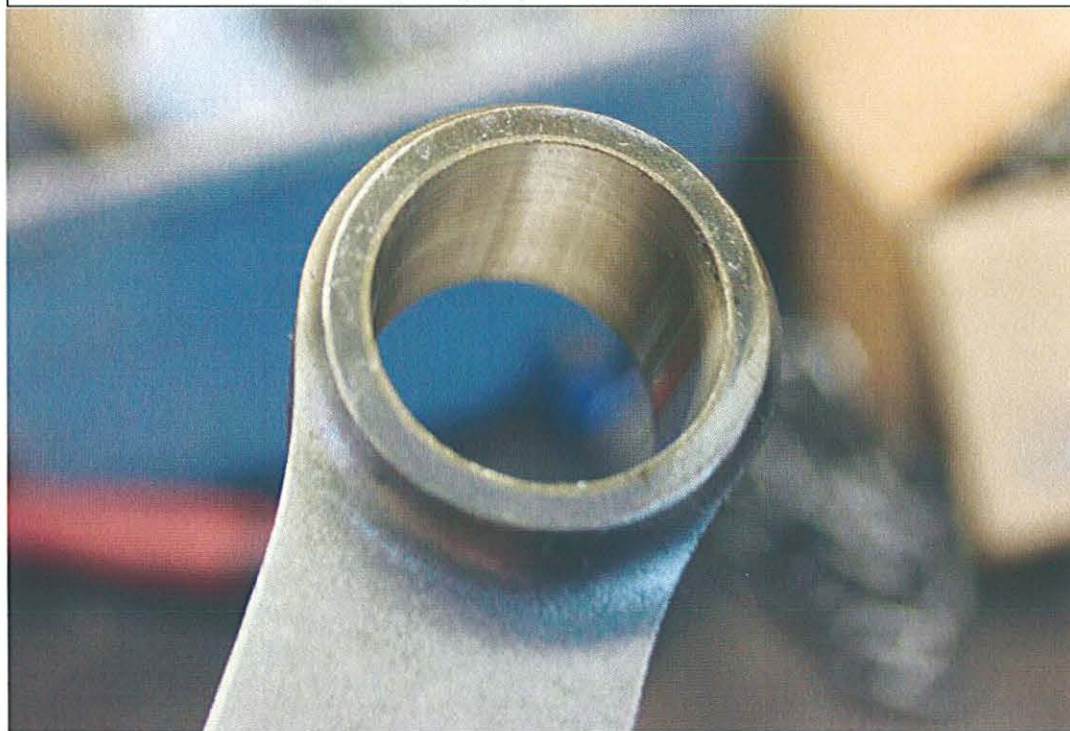
Figure B8 #378R: Minimal discoloration of piston pin bushing on cylinder #4 (image cropped)

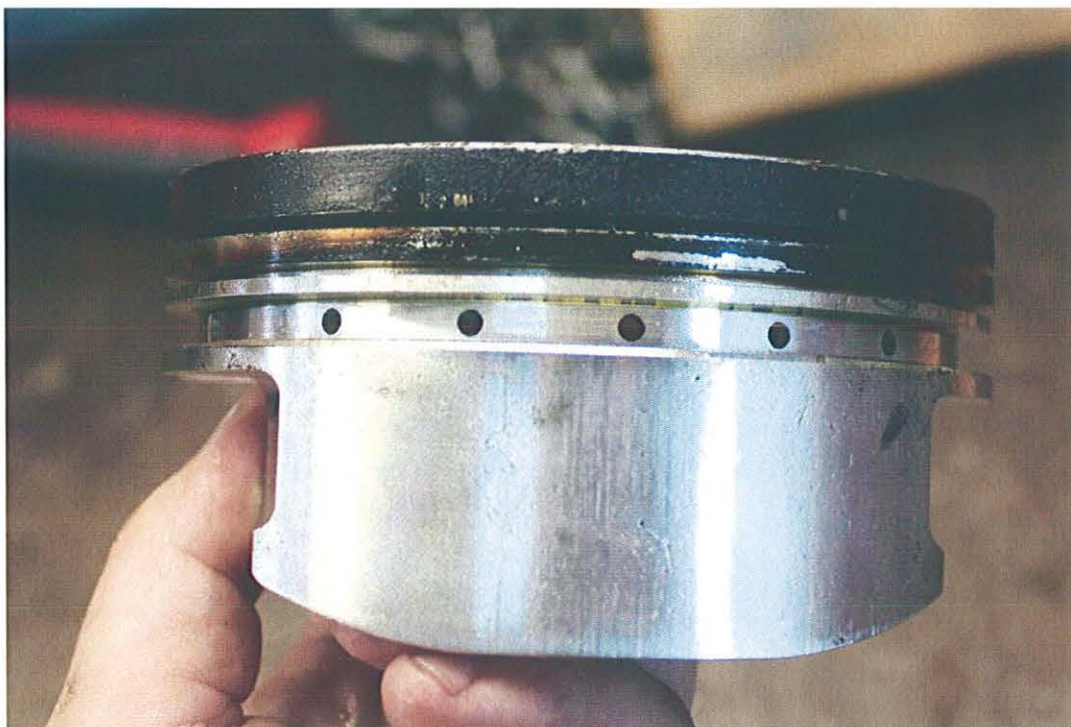
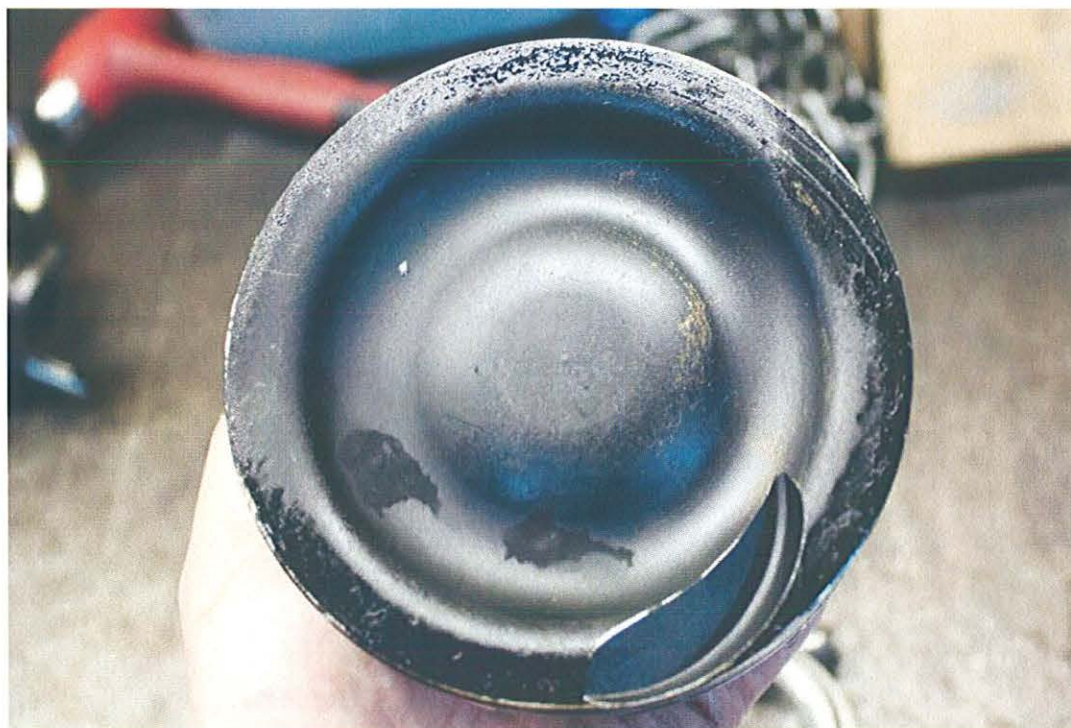
Figure B9 #378R: Deposits on piston crown on cylinder #1 (image cropped)

Figure B10 #378R: Deposits on piston crown on cylinder #7 (image cropped)

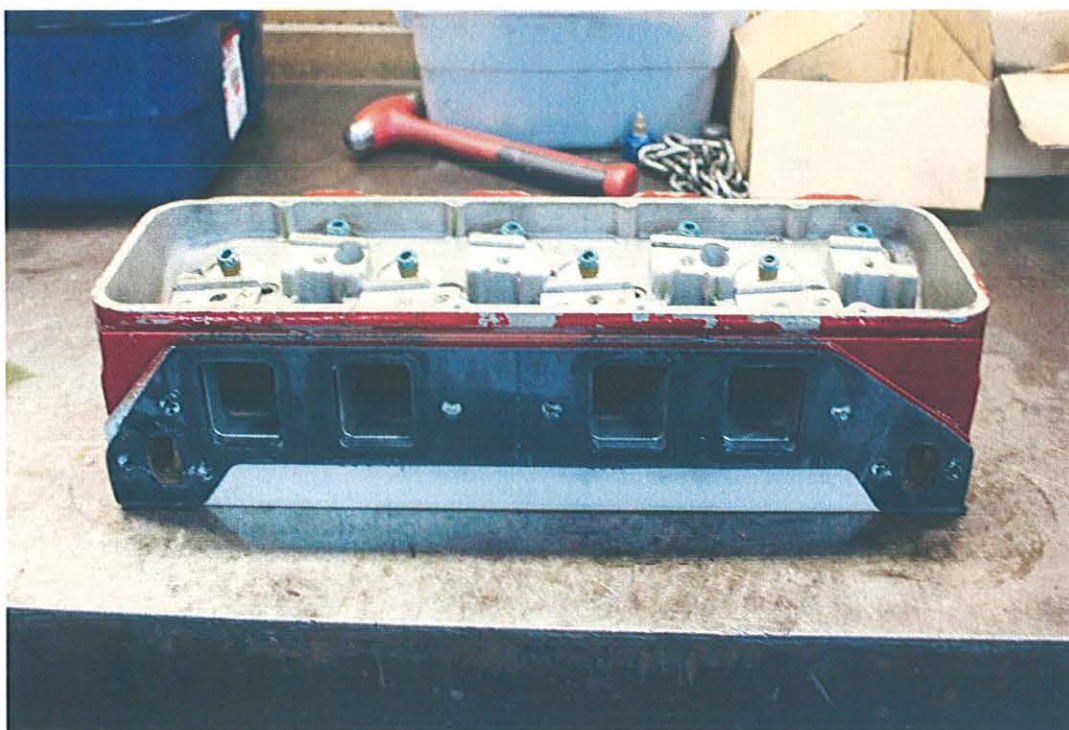
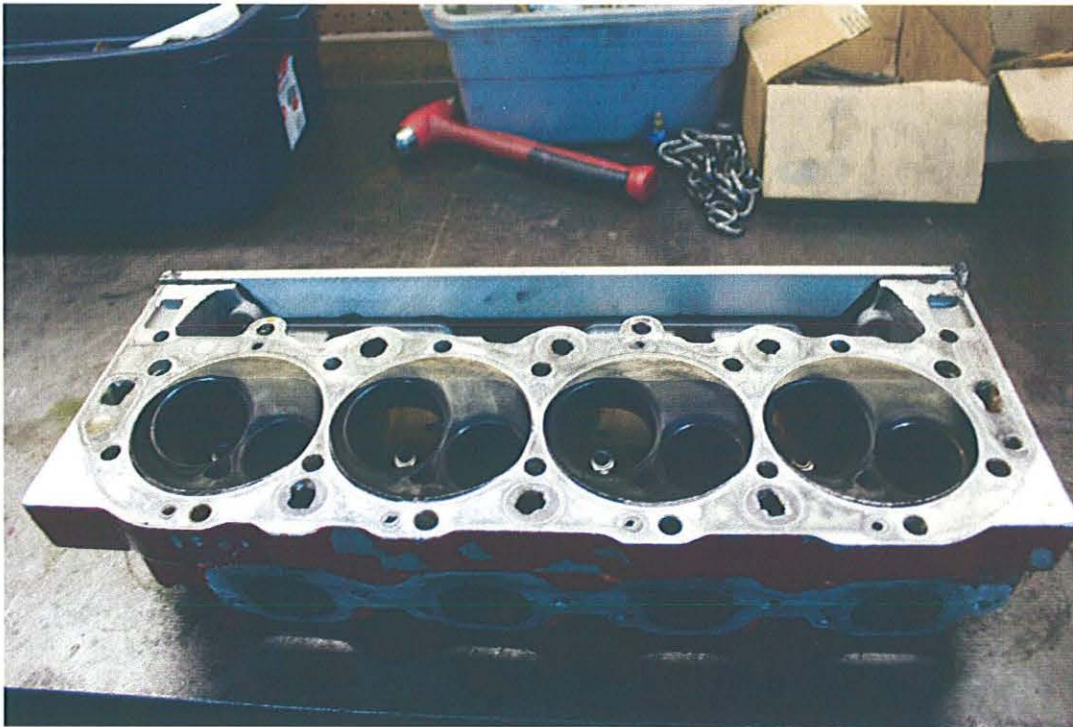
The cylinder heads were examined and there was no observable damage to either set as shown in example in Figures B12-B13. The intake and exhaust valves were examined and it was observed that some of the intake valves had carbonized build up adhered to the surfaces as shown in Figures B14-B15. The valve covers were examined, in particular, the locations of the crankcase breather vents. As with the other engine, a baffle was welded to the inside of the valve covers which impeded the crankcase breather vents as shown previously in the example in Figures 16A-17A. The crankshaft was examined and there was no observable damage that would otherwise indicate metal to metal contact.

Figure B12 #378R: Cylinder head for cylinders 2,4,6, and 8 valve train side

Figure B13 #378R: Cylinder head for cylinders 2,4,6, and 8 combustion chamber side

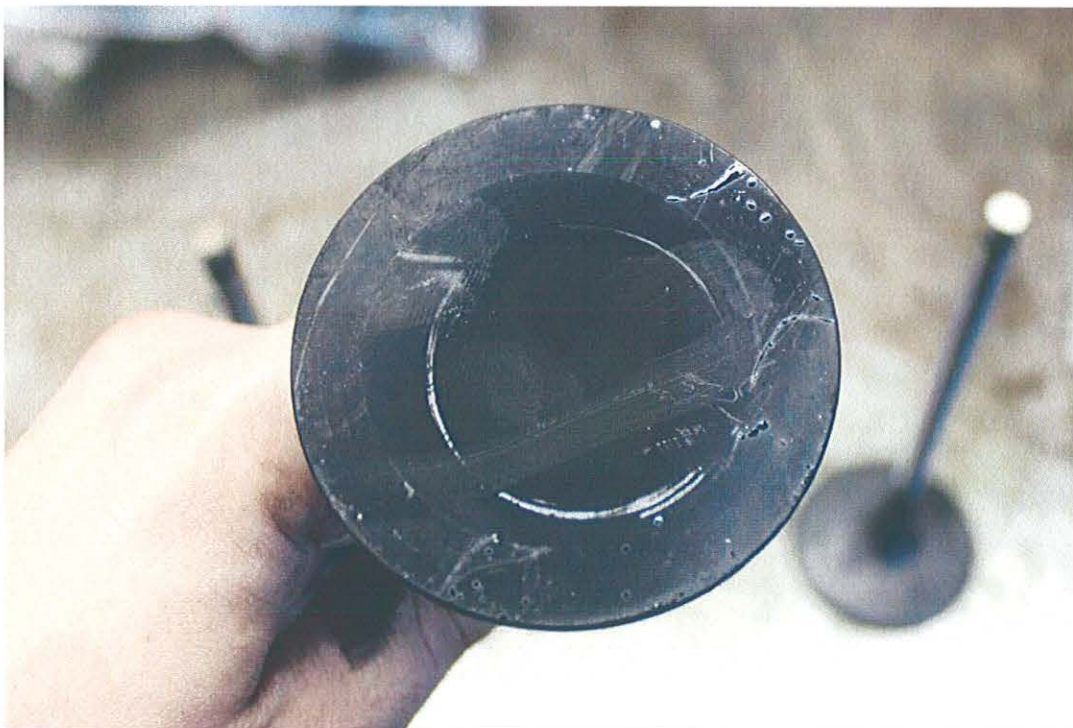
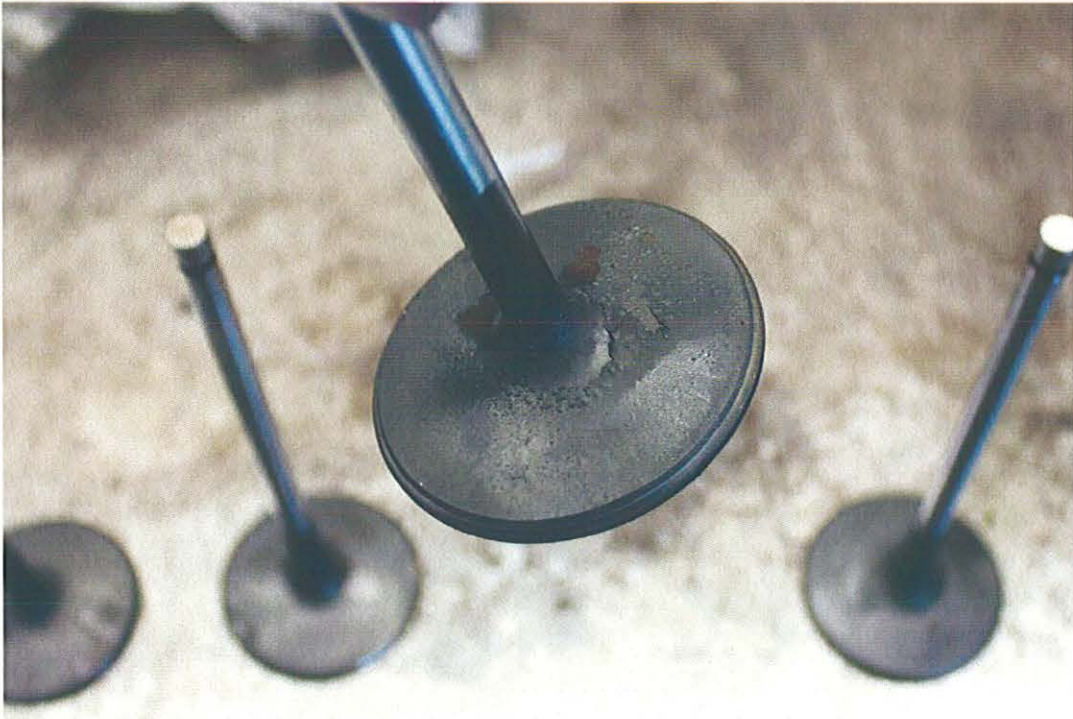
Figure B14 #378R: Carbonized buildup adhered to intake valve combustion side (image cropped)

Figure B15 #378R: Carbonized buildup adhered to intake valve combustion side (image cropped)

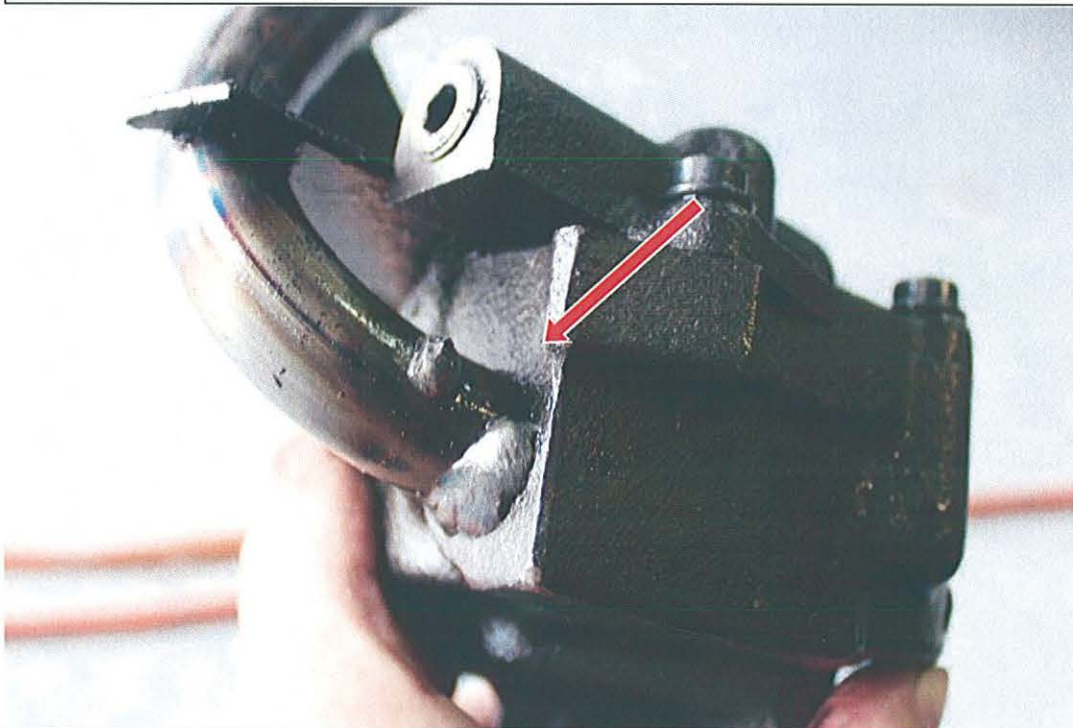
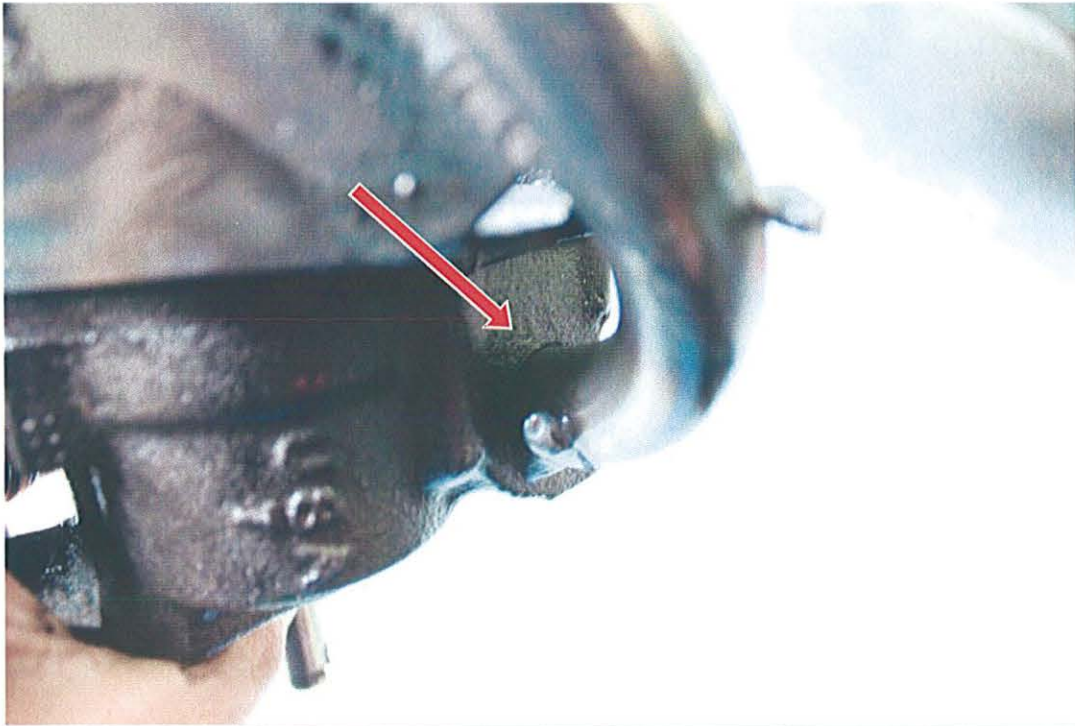
Lastly, the oil pump and oil pickup tube were examined. It was observed that the pickup tube was not seam welded around the entire interface with the oil pump housing as is shown in Figures B16-B17. A sample of oil as collected by Mr. Rinda was examined and retained by this investigation. It was visually observed that the oil was of dark color and that the viscosity of the oil was higher than would be expected for the duration of time the engine was operated as is shown in Figure B18.

Figure B16 #378R: Oil pump and oil pump pickup tube partially welded interface

Figure B17 #378R: Oil pump and oil pump pickup tube partially welded interface

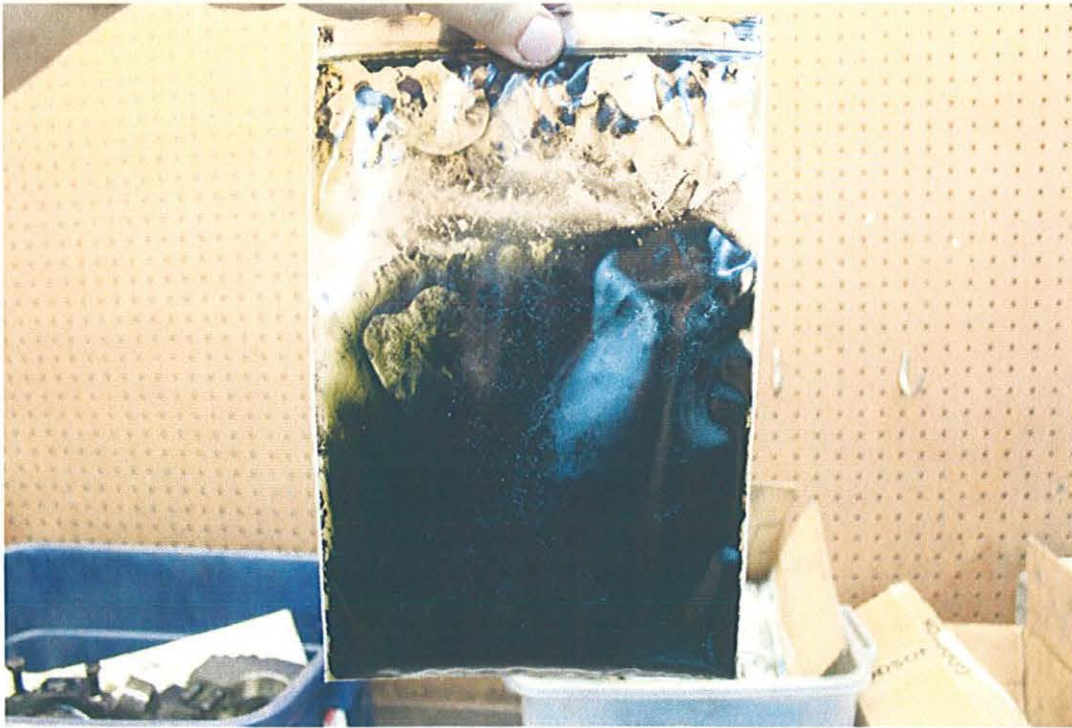
Consideration was given to the work that was invoiced to Mr. Wessinger by Crockett after the engines had been sent back as a result of improper operation. Among other items, it was reported that the oil and filters had been changed, along with honing the cylinder walls. The invoice also stated that the engine had been operated on a dynamometer. In examining the condition of the oil, it was visually observed that the viscosity of the oil was higher than would be expected should the oil have been changed and the engine operated just on the dynamometer. The dark color and viscosity indicated that oxidation of the oil took place. This determination was further indicated by the presence of thick oil residue adhered to the walls of the oil pan. It was therefore determined that the oil had not been changed when the engine was sent back to Crockett as reference by the March 12, 2011 invoice.

Figure B18 #378: Oil sample collected by MER

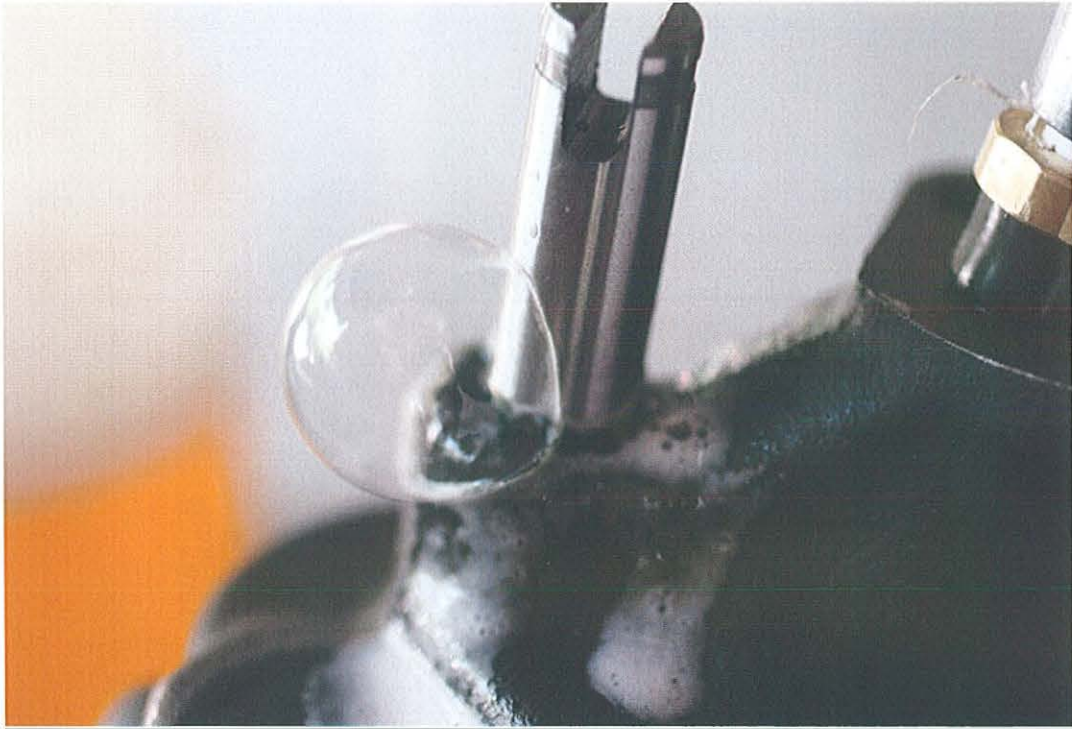
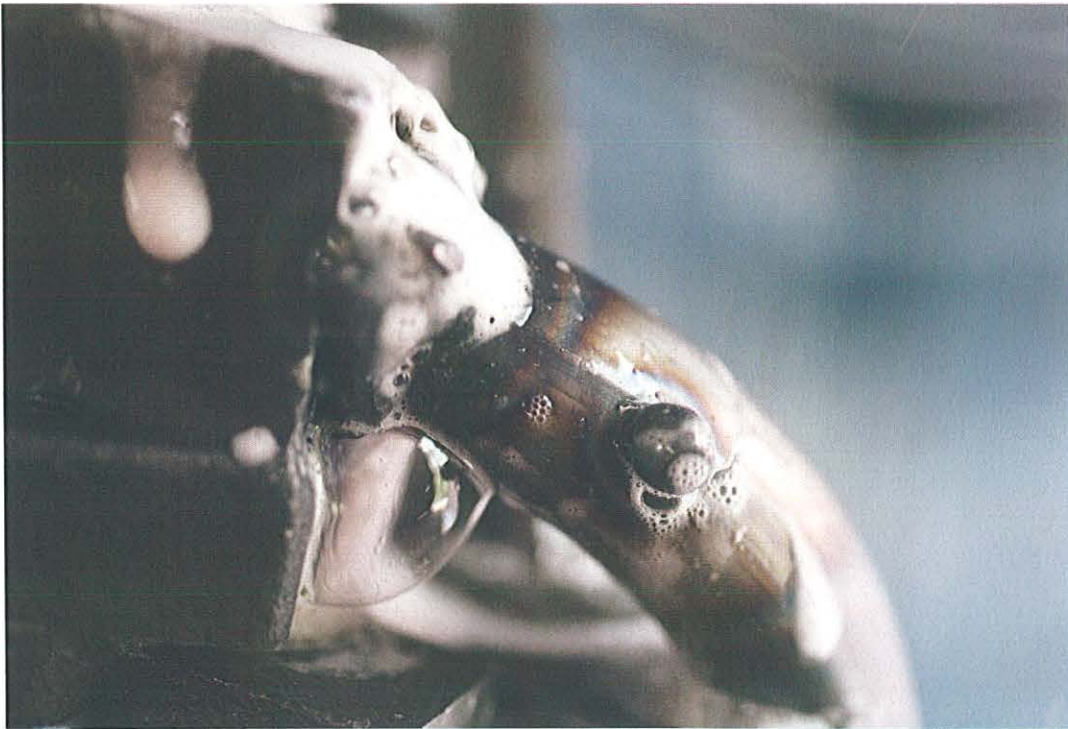
A test was conducted to evaluate whether the construction of the oil pump and pickup tube assembly was such that it would allow air to become entrained in the oil during the operation of the oil pump. A test apparatus was developed that functioned to seal the inlet side of the pickup tube. An air compressor was used to then supply air at a pressure of 20 pounds per square inch into the oil pump through the discharge port. The compressor nozzle was constructed with a rubber tip that would make a seal against the discharge port. A soapy liquid was applied to several surfaces of the oil pump and pickup tube assembly. The formation of bubbles was observed at the seal between the oil pump housing and the pump input shaft along with the mating surfaces of the oil pump housing and the pickup tube as shown in Figures C1-C2. The formation of bubbles indicated that the oil pump was not sealed against air entrainment.

Figure C1 Oil pump input shaft leak on #377R as indicated by bubble

Figure C2 Oil pump pickup tube leak on #377R as indicated by bubble

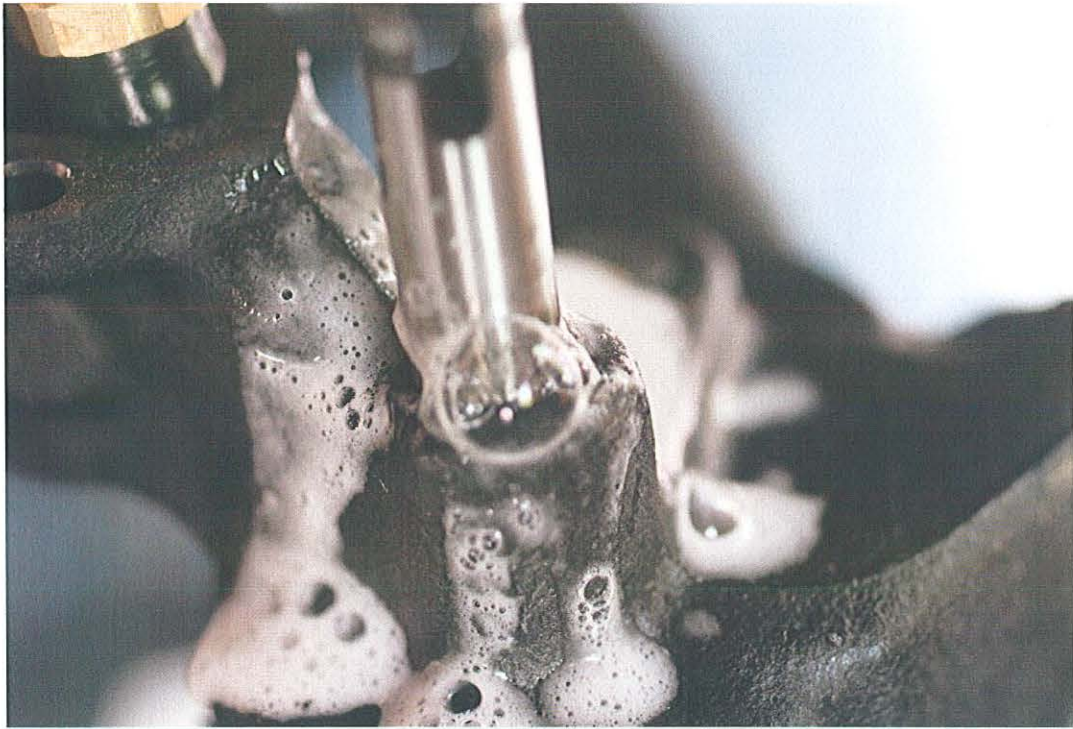
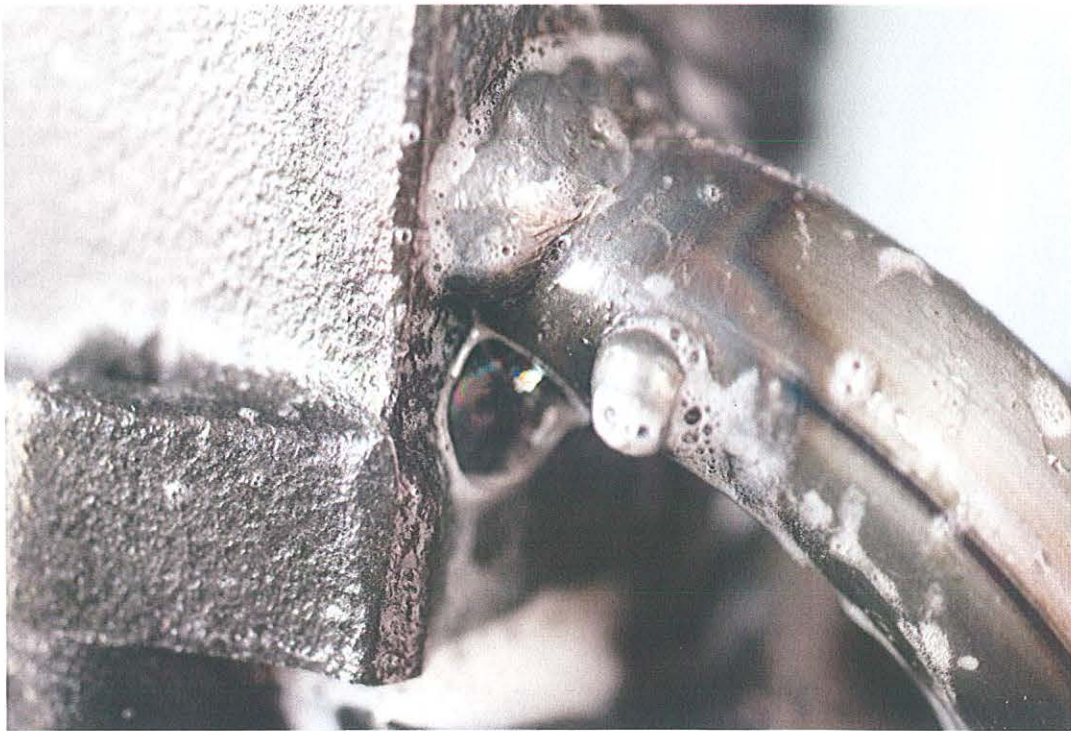
A test was conducted to evaluate whether the construction of the oil pump and pickup tube assembly was such that it would allow air to become entrained in the oil during the operation of the oil pump. A test apparatus was developed that functioned to seal the inlet side of the pickup tube. An air compressor was used to then supply air at a pressure of 20 pounds per square inch into the oil pump through the discharge port. The compressor nozzle was constructed with a rubber tip that would make a seal against the discharge port. A soapy liquid was applied to several surfaces of the oil pump and pickup tube assembly. The formation of bubbles was observed at the seal between the oil pump housing and the pump input shaft along with the mating surfaces of the oil pump housing and the pickup tube as shown in Figures C3-C4. The formation of bubbles indicated that the oil pump was not sealed against air entrainment.

Figure C3 Oil pump input shaft leak on #378R as indicated by bubble

Figure C4 Oil pump pickup tube leak on #377R as indicated by bubble
